Subject: July and August 2017 Cultural Resource Monitoring Report for Expanded Area of Potential Effects
Leviathan Mine Site
Alpine County, California

Page 1 of 59 *Resource Name or #: Temporary # JDH_1702

P1. Other Identifier: Camp Isbell

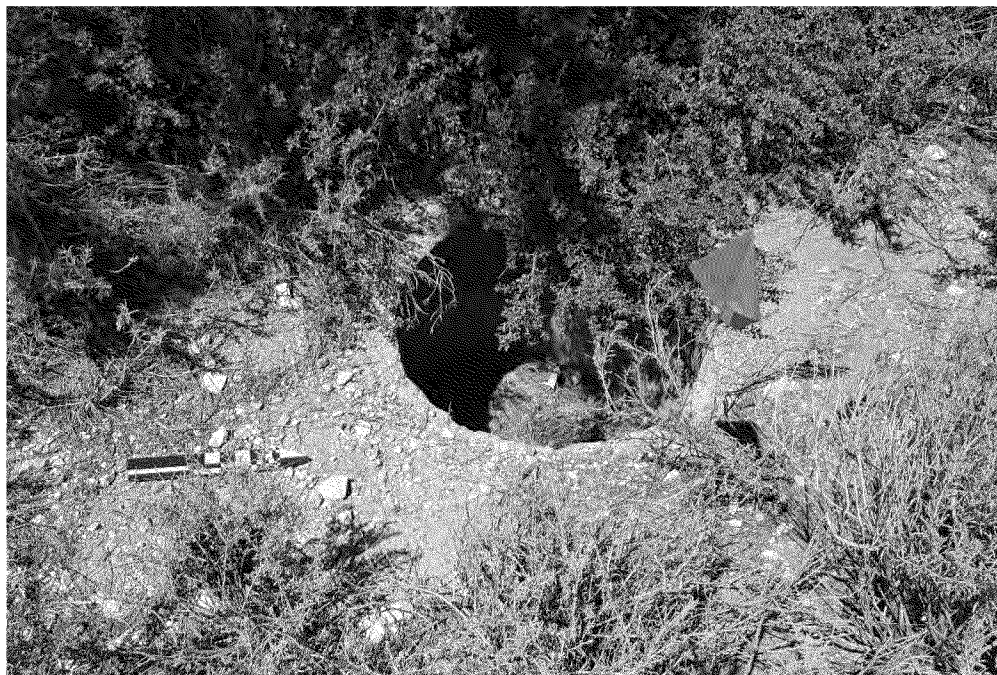
JDH_1702/Camp Isbell, Overview of Feature F-26, concrete cistern, plan view,
20170717_120016.jpg

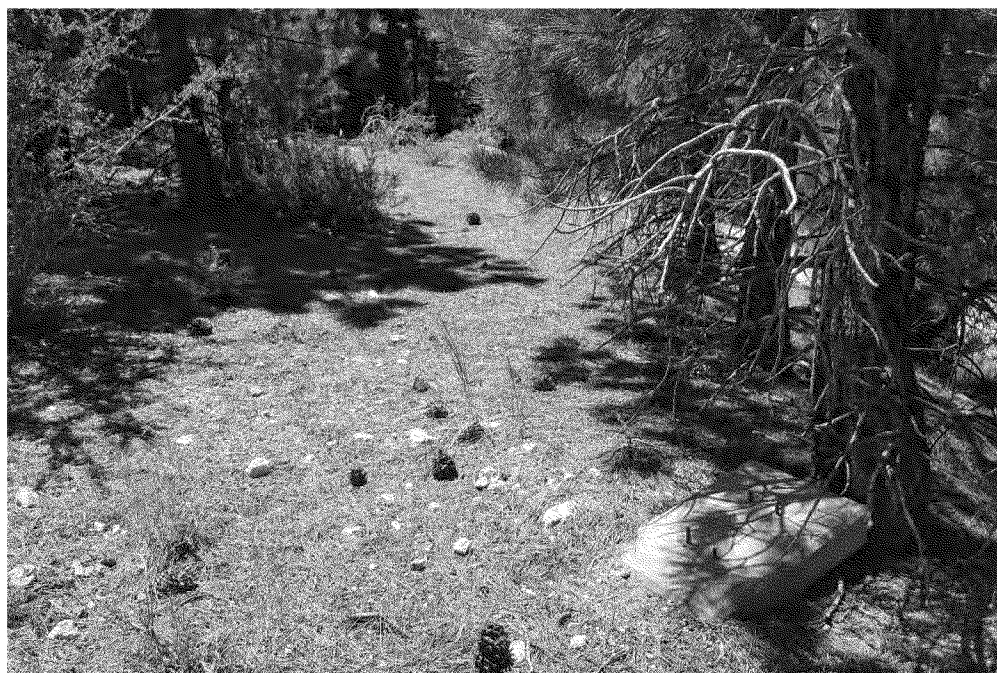
JDH_1702/Camp Isbell, Overview of Features F-27A, F-27B, F-27C, and F-27D (identical
concrete footings), facing south, 20170717_120144.jpg

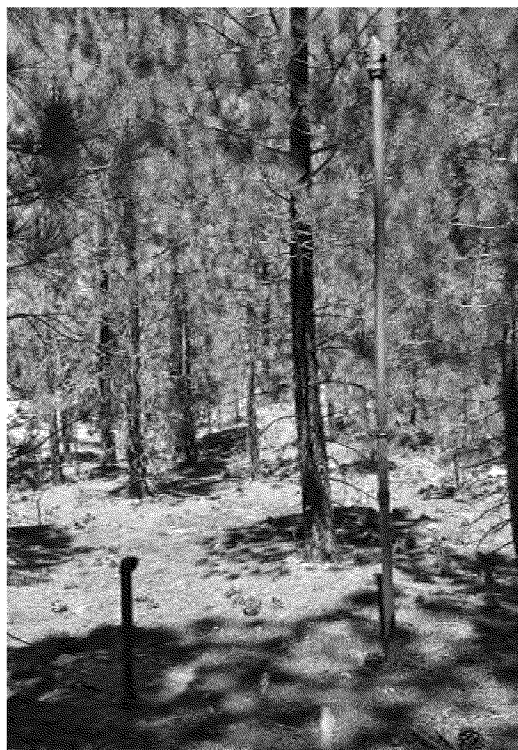
JDH_1702/Camp Isbell, Overview of Feature F-29, two standing pipes, facing northwest-north,
20170717_133452.jpg

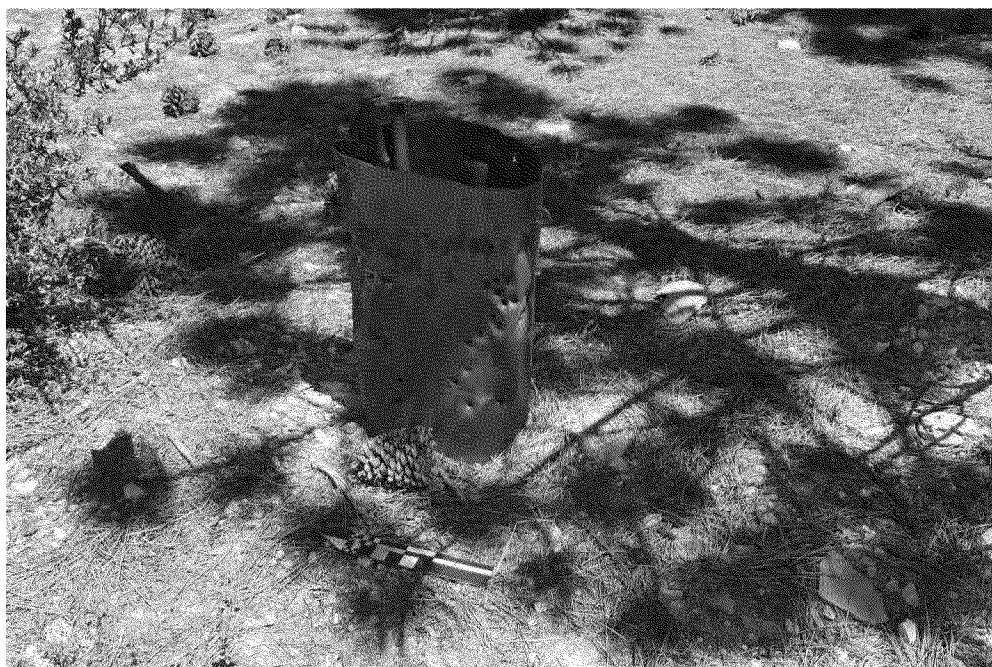
JDH_1702/Camp Isbell, Overview of Feature F-30, well head, facing east,
20170717_133746.jpg

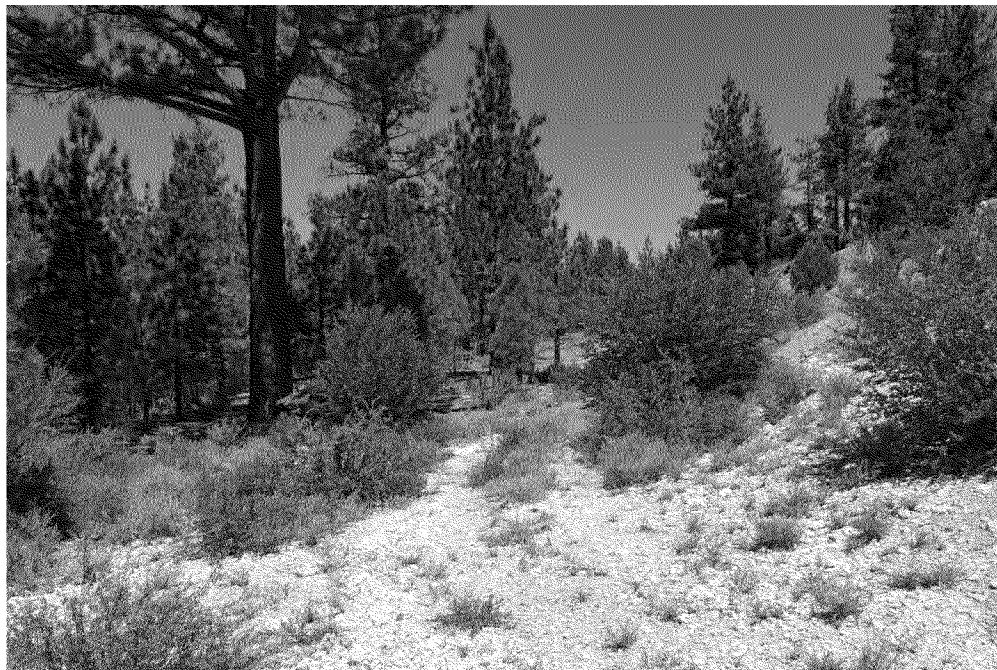
JDH_1702/Camp Isbell, Overview of Feature F-31, road from the south end of camp area, facing north, 20170717_120514.jpg

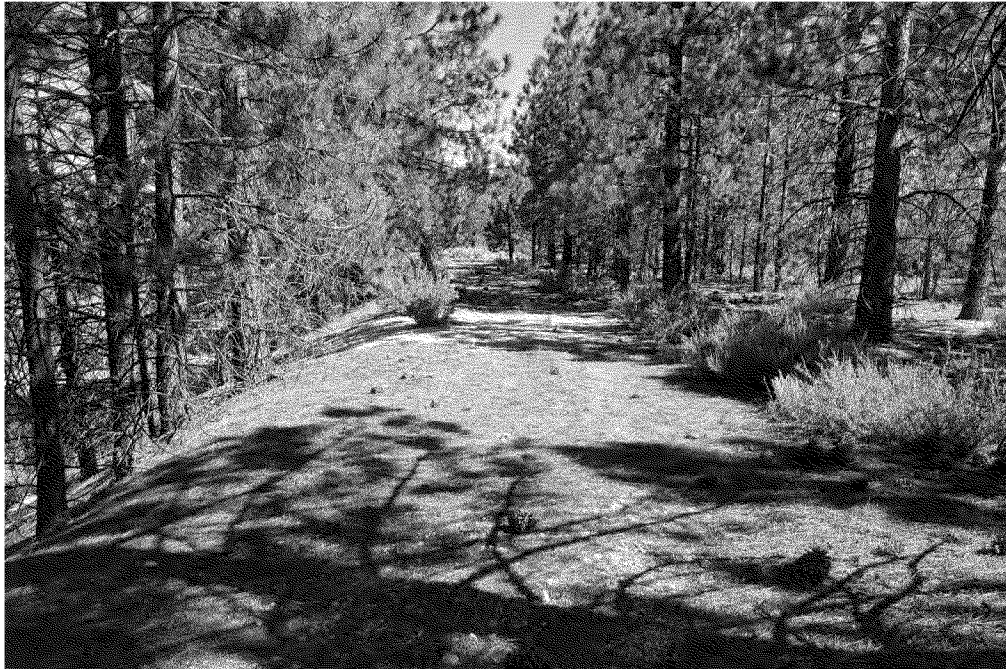
JDH_1702/Camp Isbell, Overview of Feature F-31, road, facing northwest-north,
20170717_095717.jpg

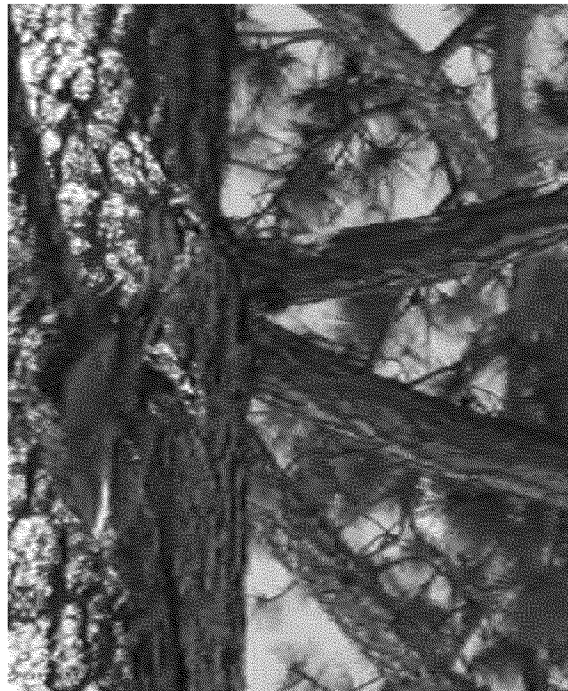
JDH_1702/Camp Isbell, Feature F-32, tree-mounted brown ceramic insulator (on tree branch),
facing north, 20170717_132452.jpg

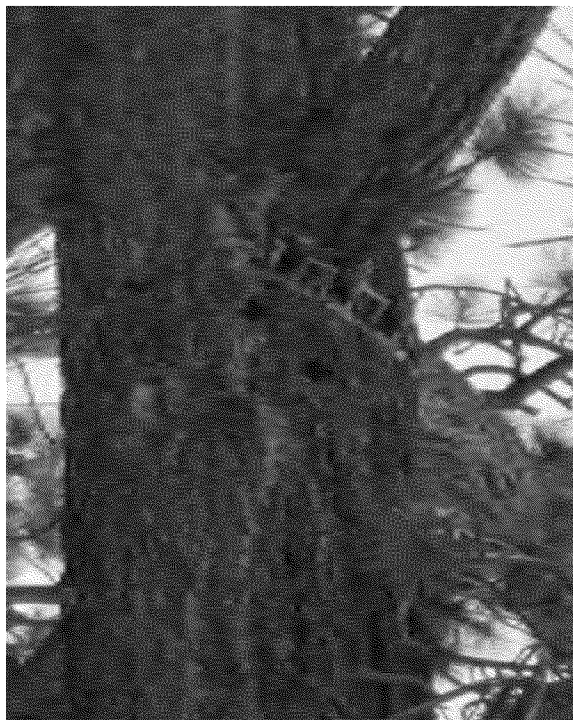
JDH_1702/Camp Isbell, Feature F-33, tree-mounted insulator hub, facing south-southwest,
20170717_133308.jpg

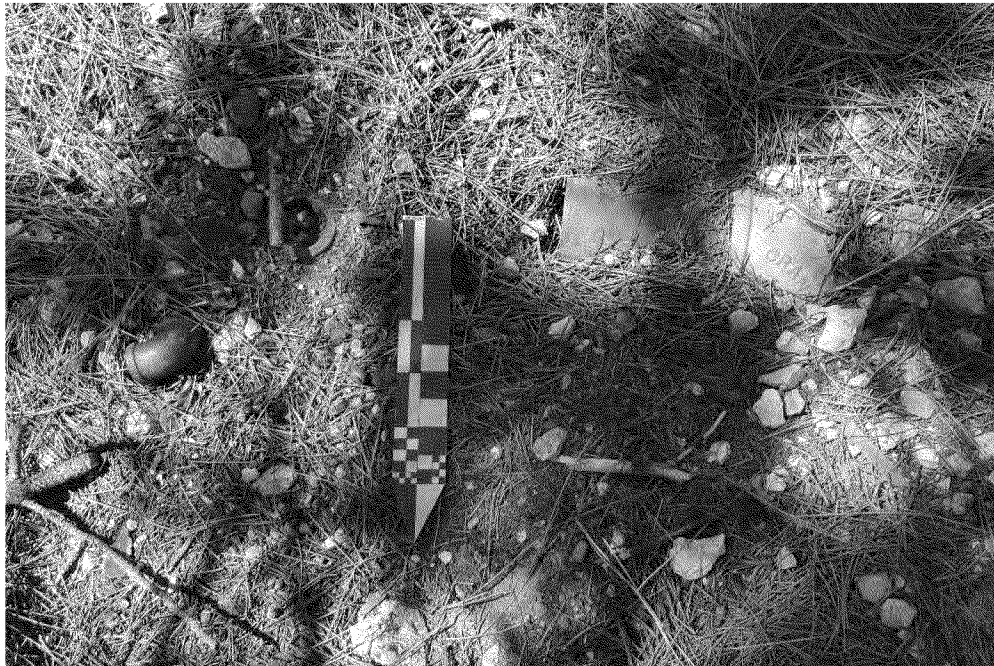
JDH_1702/Camp Isbell, Overview of Feature F-35, buried pipe with “CRANE” makers mark and buried valve, plan view, 20170717_112248.jpg

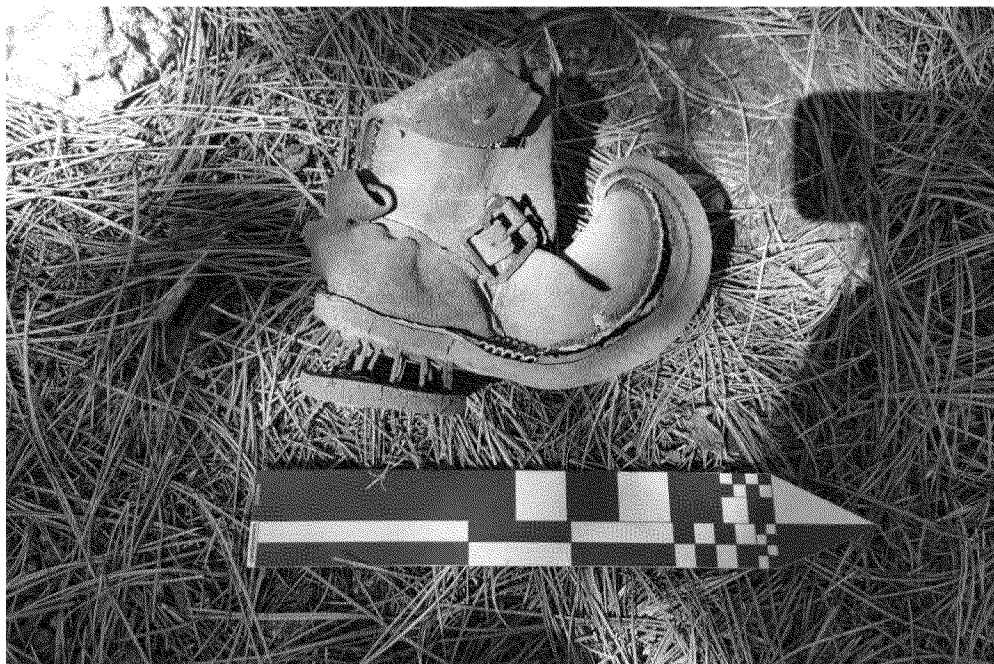
JDH_1702/Camp Isbell, Artifact A-01, boot, plan view, 20170717_102944.jpg

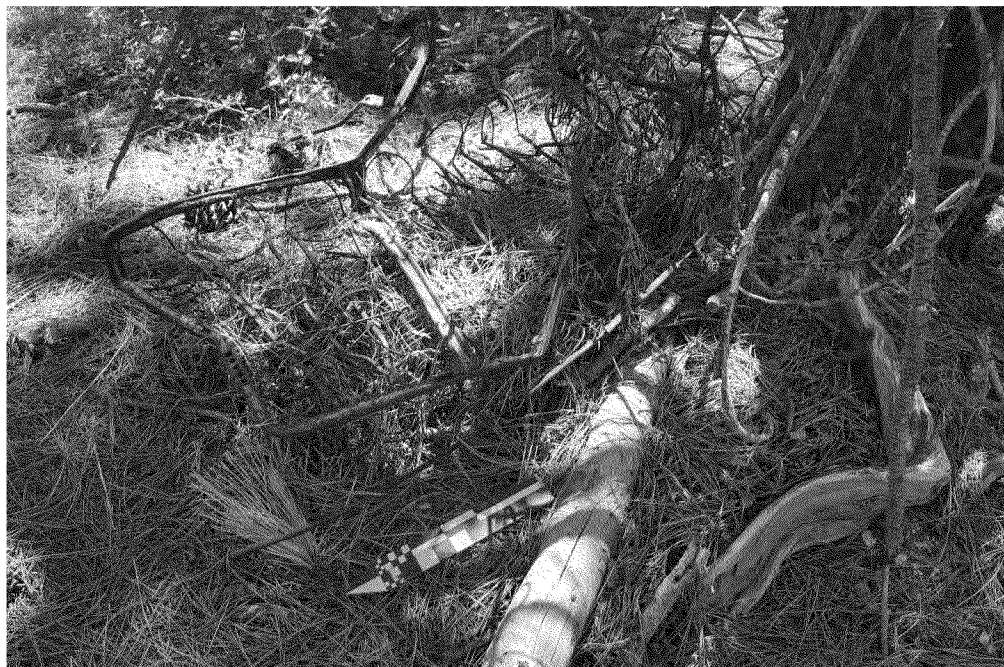
JDH_1702/Camp Isbell, Artifact A-02, vehicle bench springs, plan view, 20170717_114806.jpg

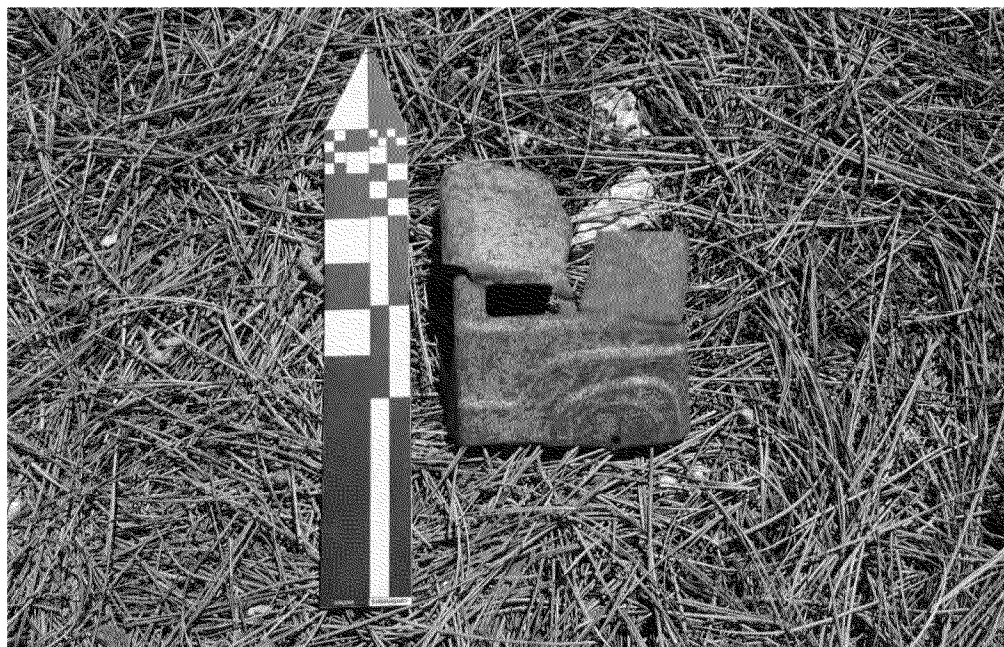
JDH_1702/Camp Isbell, Artifact A-03, toy truck fragment, plan view, 20170717_110410.jpg

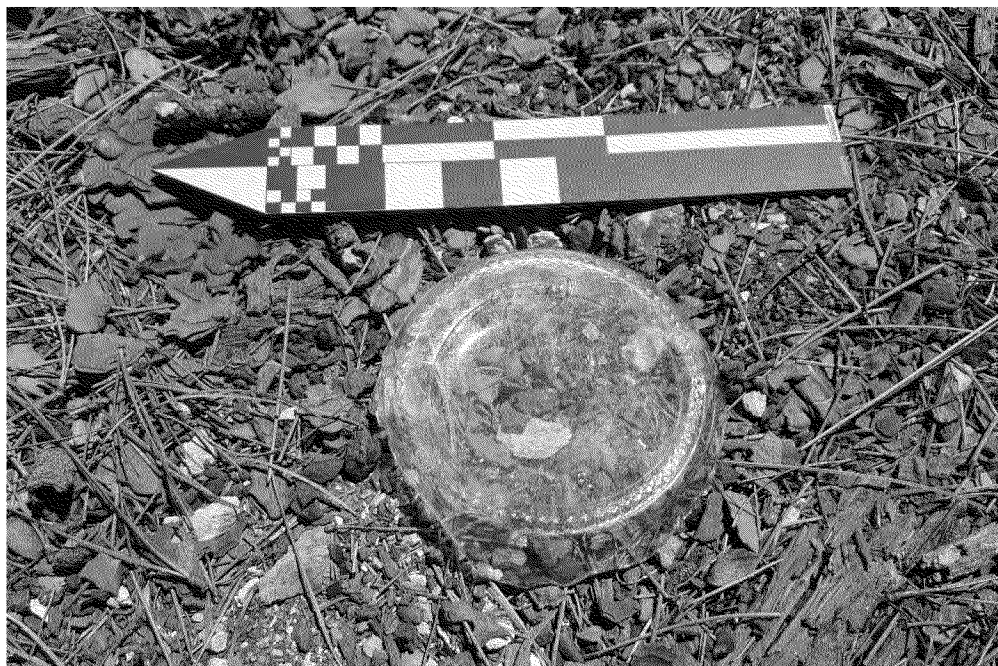
The Owens-Illinois glass manufacturing company mark appears on two of the artifact specimens; **Artifacts: A-04, A-05**. There are two Owens-Illinois maker's marks found on these glass bottles: The first is the combination of the two merging companies' original logos and is known as the "I-O diamond" and was first used around 1930. The second mark, known as the "I-in-a-Oval" mark, was first introduced in 1954. In addition to this distinct time marker, the Owens-Illinois company also began providing date-codes during the 1930s with a factory code and a date code on the bottle bases that appear below the O-I mark. While these codes are not completely without fault, it would appear that the clear glass gallon jug base, **Artifact A-04**, was manufactured in 1963 at the Oakland, California plant and that the clear glass bottle base **Artifact A-05** is the base to a bottle that was manufactured in 1934 at the San Francisco, California plant (Lockhart and Hoening 2004 and 2015).

JDH_1702/Camp Isbell, Artifact A-04, clear glass jug base, plan view, 20170717_134134.jpg

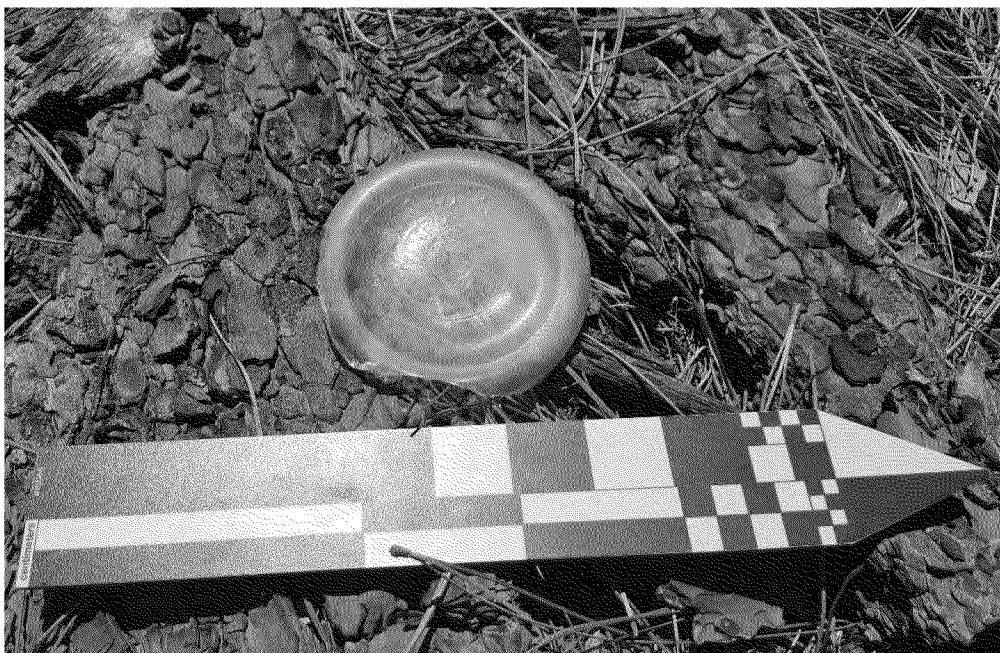
JDH_1702/Camp Isbell, Artifact A-05, clear glass bottle base, plan view, 20170717_134401.jpg
